# Manhole Inspection Summary

Manhole # S21M\_\_005MH

**Location** Address: **425 s payson st**

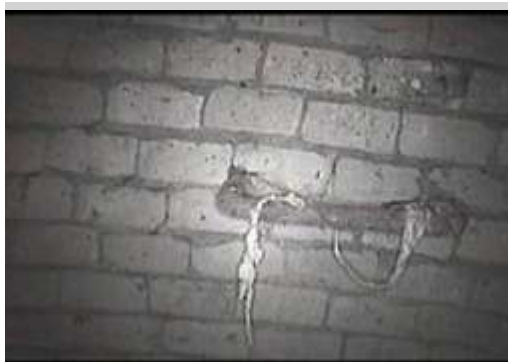
Defect 4

☒ **Evidence Of Surcharge**

Depth: **3**

evidence of surcharge

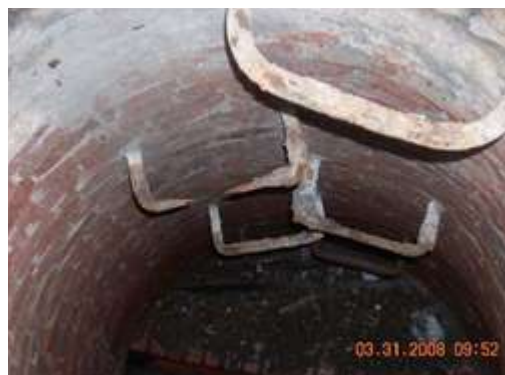
Defect 3

Count: **5**

Missing: **1**

☒ **Corroded**

deteriorated and missing steps

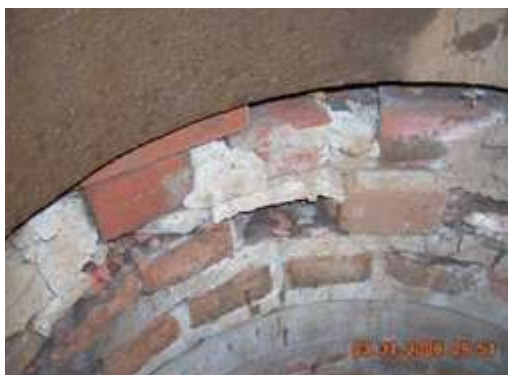
Defect 2

☒ **Cracked**

☒ **Loose Brick**

loose chimney bricks and cracked chimney

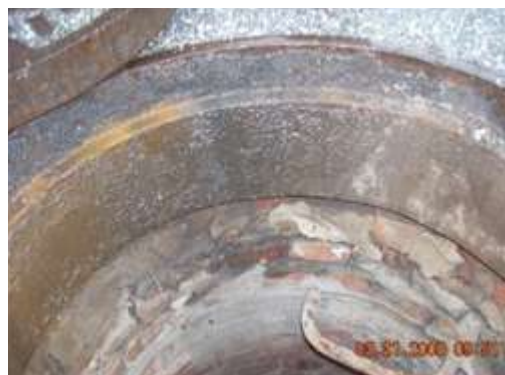
Defect 1

☒ **Leaks**

inflow evidence on frame/chimney

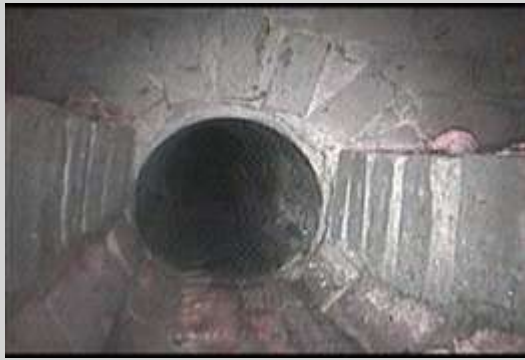
12 O'Clock Outflow

Pipe Height: **8.4** (in.) Rod and Bar (Angled)  
Pipe Material: **Clay** ☐ Pipe Lined  
Invert Depth: **10.10** (ft.) Flow Characteristics: **Slow**  
Deposits: ☒ None ☐ Mud ☐ Sludge ☐ Debris ☐ Grease  
Silt Depth: **0** (in.) Deposits Extent:  
Infiltration: **None** Pipe Seal Cond: **Sound**

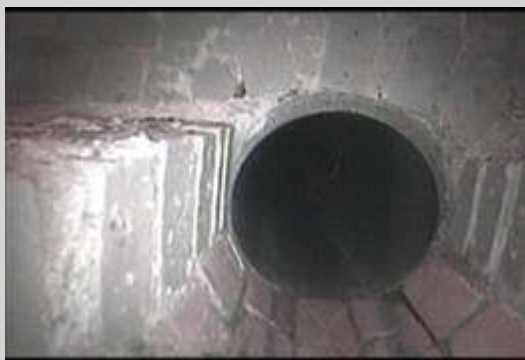
3 O'Clock Inflow

Pipe Height: **7.2** (in.) Rod and Bar (Angled)  
Pipe Material: **Clay** ☐ Pipe Lined  
Invert Depth: **9.85** (ft.) Flow Characteristics: **Slow**  
Deposits: ☒ None ☐ Mud ☐ Sludge ☐ Debris ☐ Grease  
Silt Depth: **0** (in.) Deposits Extent:  
Infiltration: **None** Pipe Seal Cond: **Sound**

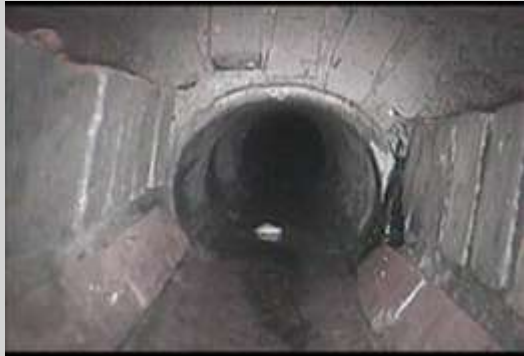
6 O'Clock Inflow

Pipe Height: **7.2** (in.) Rod and Bar (Angled)

Invert Depth: **10.07** (ft.) Flow Characteristics: **Slow**

Infiltration: **None** Pipe Seal Cond: **Sound**
